INVENTORY
of
POTENTIAL and EXISTING
UPSTREAM RESERVOIR SITES
CHICOPEE STUDY AREA
Massachusetts

U.S. DEPARTMENT of AGRICULTURE
Soil Conservation Service
Economic Research Service
Forest Service

MASSACHUSETTS WATER RESOURCES COMMISSION

MAY 1973

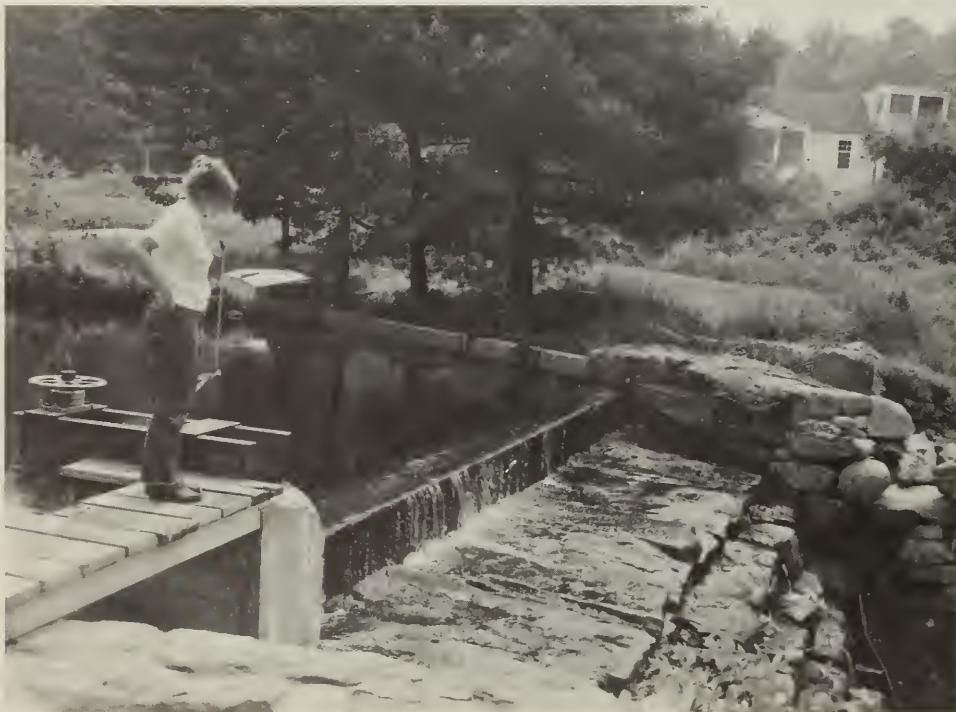
SITE CP-2750 (Lake Mattawa)

Remarks: The dam is a 300 foot long earth-fill structure with a 10 foot top width. The dam is located at the south end of the lake. The upstream slope is riprapped; the downstream slope is grassed. The principal spillway is a rock masonry weir, 15 feet long and 4 feet deep. There is also a controlled outlet at the north end of the lake. The masonry weir shows signs of crumbling. The rock apron of the outlet channel has partially eroded.

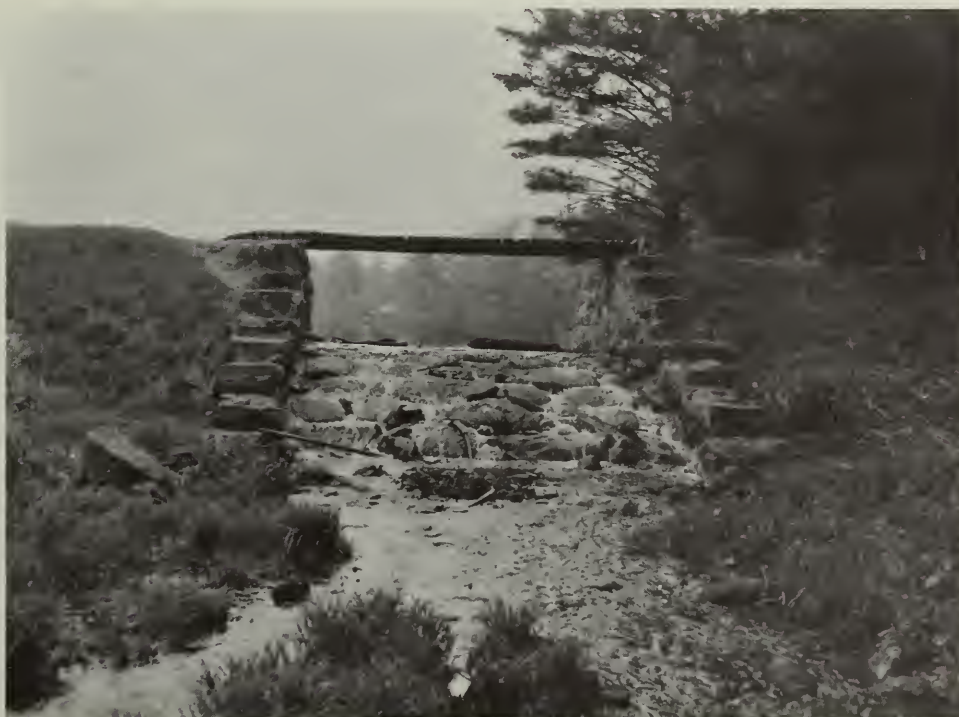
SITE CP-2751
(Carter Pond)

Remarks: The dam is a 105 foot long concrete drop structure with 4-foot high flashboards to control water level. Concrete in the right abutment is cracking.

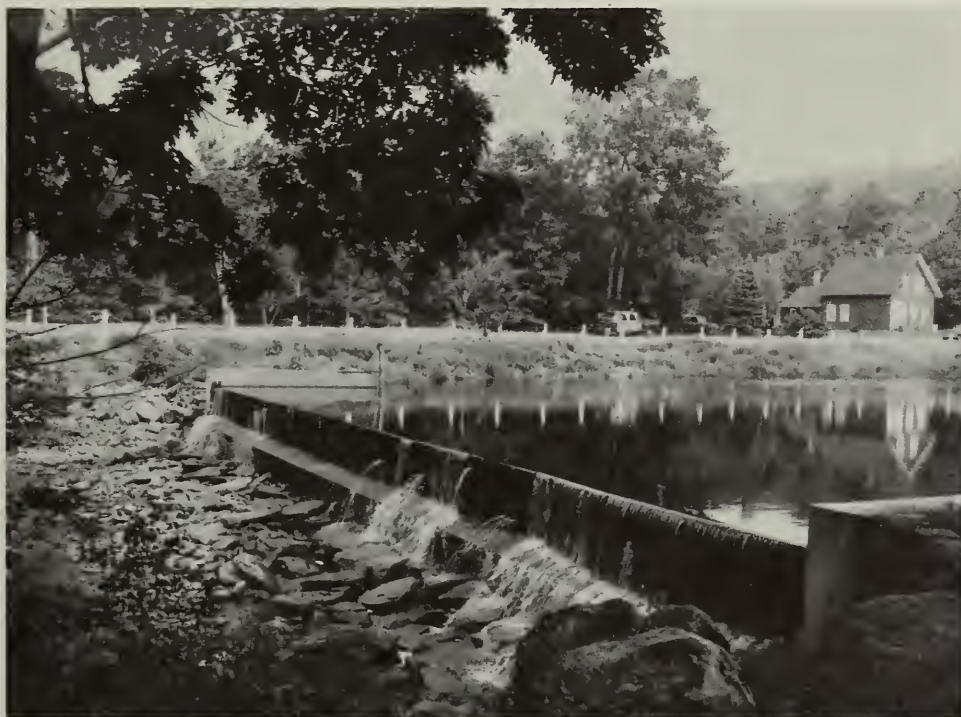
SITE CP-2753 (Gaston Pond)

Remarks: The dam is a part of the Mill Road highway embankment. It is 200 feet long with a 28 foot top width. The dam has stone facing on the upstream side. The spillway is a round crested concrete weir, 10 feet long and 3.5 feet deep. Both slopes of the dam have trees and brush growing on them.

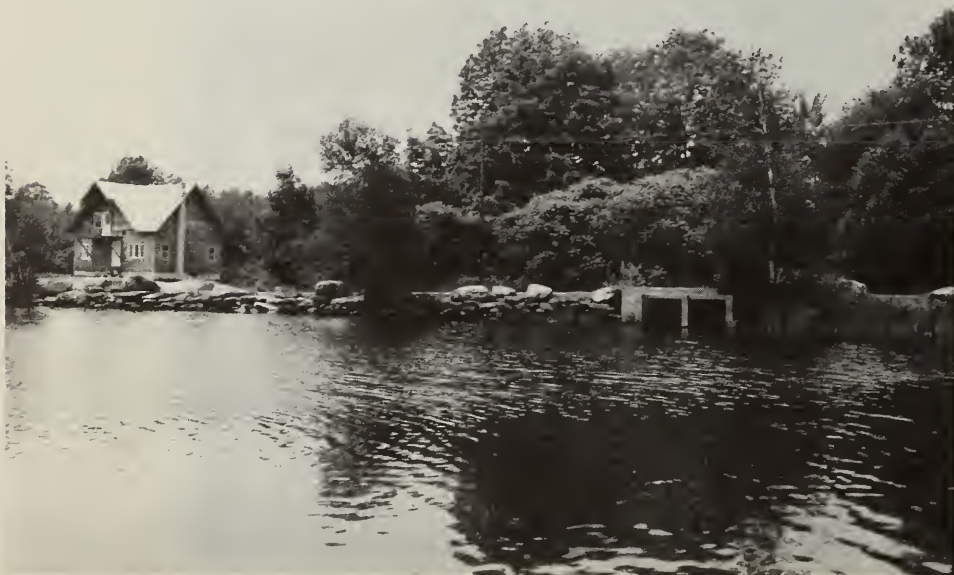
SITE CP-2754 (Quabbin Reservoir)

Remarks: Winsor Dam is a 2640 foot long earth-fill structure with a 35 foot top width. The upstream slope is riprapped; the downstream slope is grassed. Water is delivered to communities by means of the Quabbin Aqueduct. The total storage capacity of the Quabbin Reservoir is 1,265,000 acre-feet. Goodnough Dike, a 2140 foot long earth-fill dam located to the east of Winsor Dam is used to maintain the reservoir level. Both structures are well maintained.

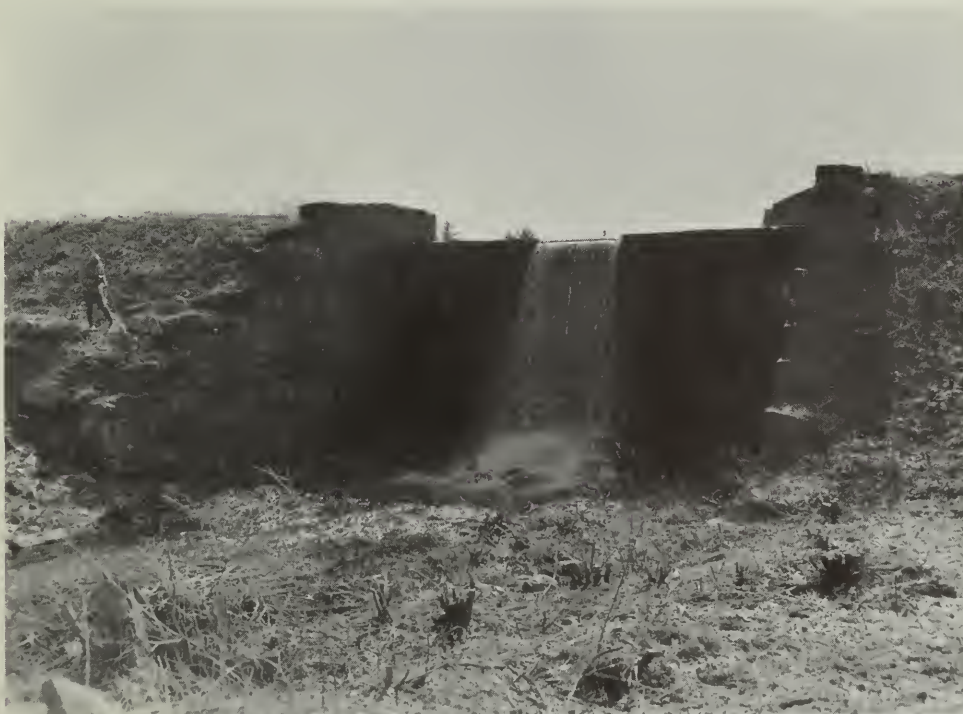
SITE CP-2814 (Springfield Reservoir)

Remarks: The Springfield Reservoir complex is a series of three reservoirs; one main reservoir and two smaller pools. Three of the dams which maintain the reservoirs are vegetated earth-fill structures with riprap on the upstream slopes. The dams are known as Gatehouse Dam and Basin Dams #1 and #2. Each dam has a gated outlet. A second control on the main reservoir is the Cherry Valley Dam, a concrete ogee weir structure. Concrete at the toe of the structure is spalling.

Remarks: The pond is contained by two dams. The Blackman-Walker Dam is a 100 foot long concrete weir structure located on the natural stream. The Springfield Water Department Canal Dam is a 36 foot long stone masonry structure which outlets into Jabish Canal through a 4-foot wide, 5-foot high gated opening. The dam and pond were constructed to divert flows to the Springfield Reservoir (Site CP-2814).

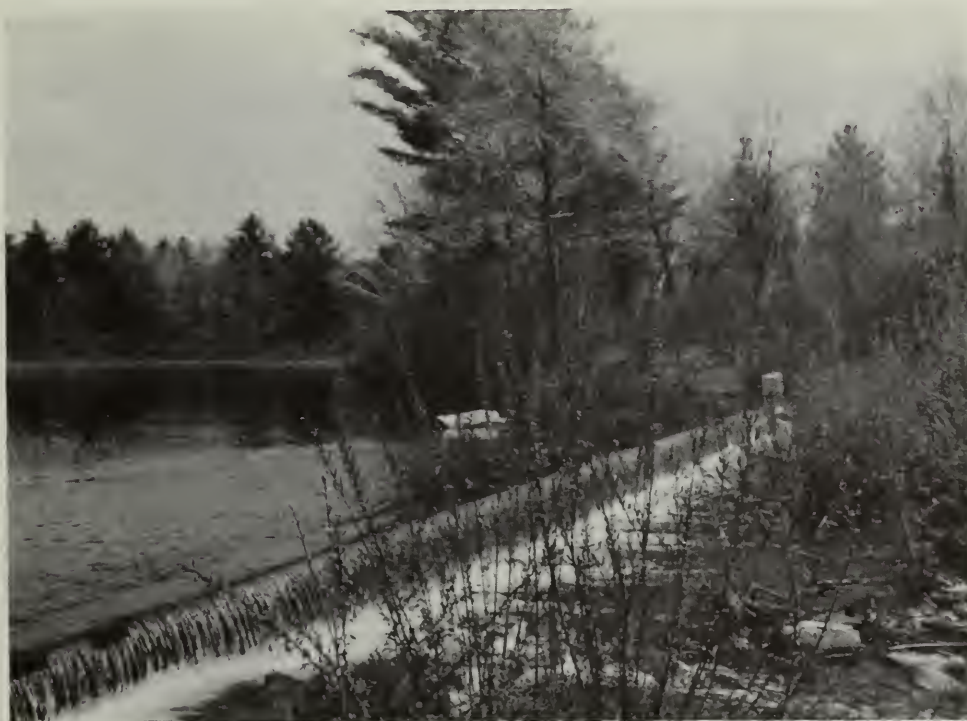
SITE CP-2816
(Ludlow Manufacturing Associates Dam)

Remarks: The dam is an 800 foot long earth-fill structure with a 6 foot top width. The spillway is a 150 foot long concrete ogee weir section. A gate house at the left abutment releases flow under the Red Bridge. The upstream and downstream slopes of the dam have light brush growing on them. Concrete in the spillway is spalling in places.

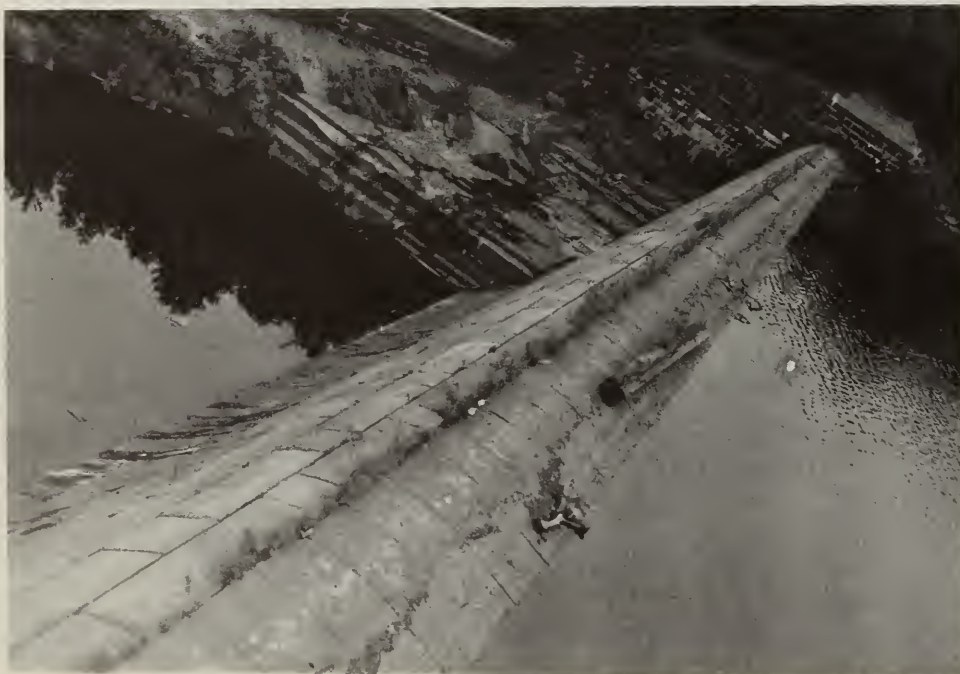
SITE CP-2817
(Bondsville Lower Dam)

Remarks: The dam is a 125 foot long stone masonry drop structure with a weir depth of 4 feet. There is a 4 foot wide, 5 foot high, control gate on the right abutment. The pool appears to be about 80% filled with silt.

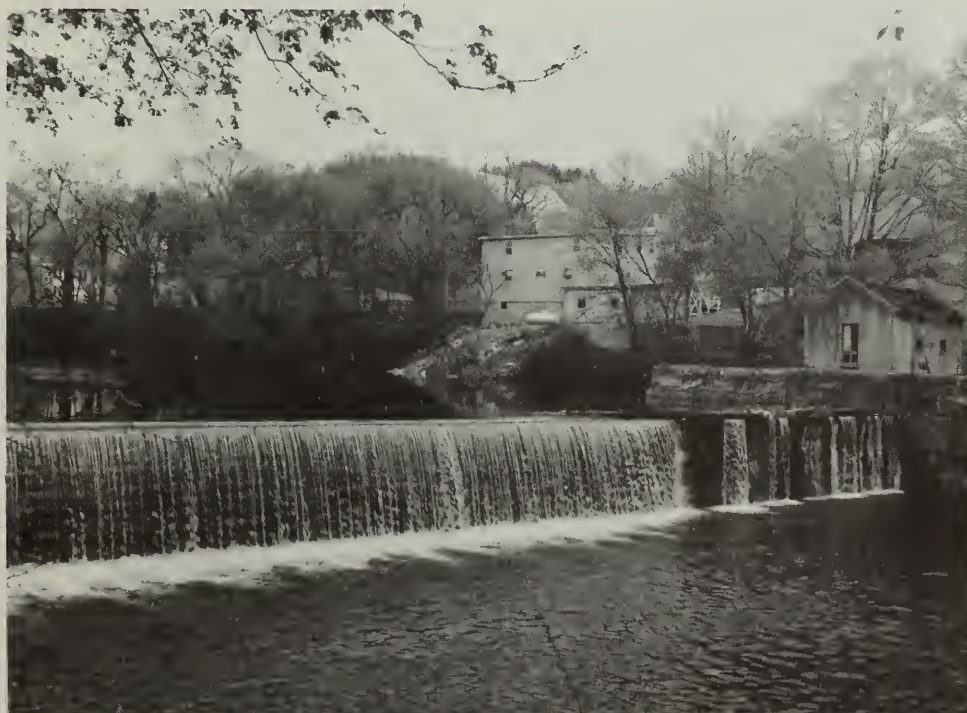
SITE CP-2818
(Bondsville Upper Dam)

Remarks: The dam is a stone masonry structure with 18" high flashboards to control the water level. There is a canal and control gate on the left abutment. The pool contains a great deal of silt. There are several leaks through the flashboards.

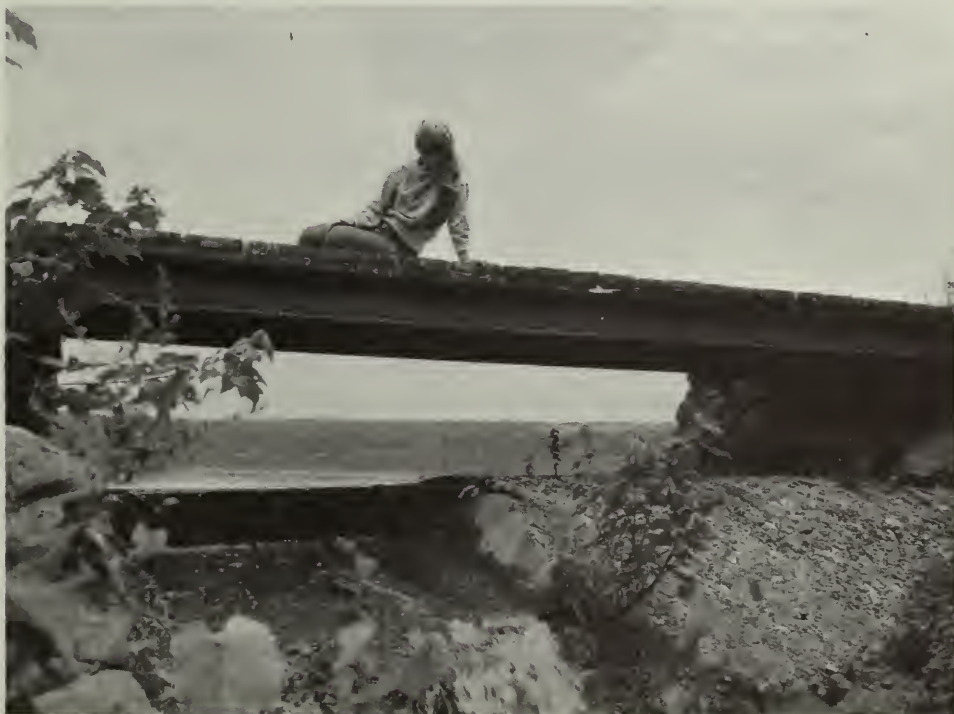
SITE CP-2941 (Queen Lake)

Remarks: The dam is an 880 foot long earth-fill structure with a 20 foot top width. The upstream slope is riprapped; the downstream slope is grassed. The principal spillway is a gated concrete box structure. A vegetated emergency spillway, located near Bickford Pond Road, is 50 feet wide and 2000 feet long. The dam is very well maintained.

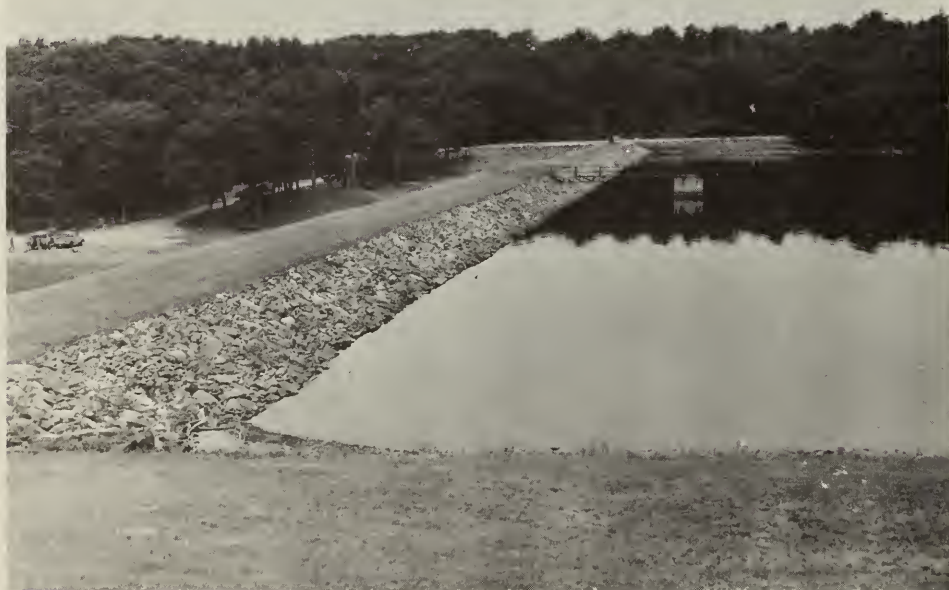
SITE CP-2946 (Bickford Pond)

Remarks: The following statistics apply to the new dam being constructed by the City of Fitchburg. The dam is a 950 foot long earth-fill structure with a 15 inch thick concrete core wall. The upstream slope is rip-rapped and the downstream slope is grassed. The spillway is 100 feet long with a concrete box drop inlet. There is also a 2500 foot long earth-fill dike with a 15 inch thick concrete core wall. Bickford Pond has a capacity of 800 million gallons. It is used as a backup reservoir for Mare Meadow (Site CP-2945).

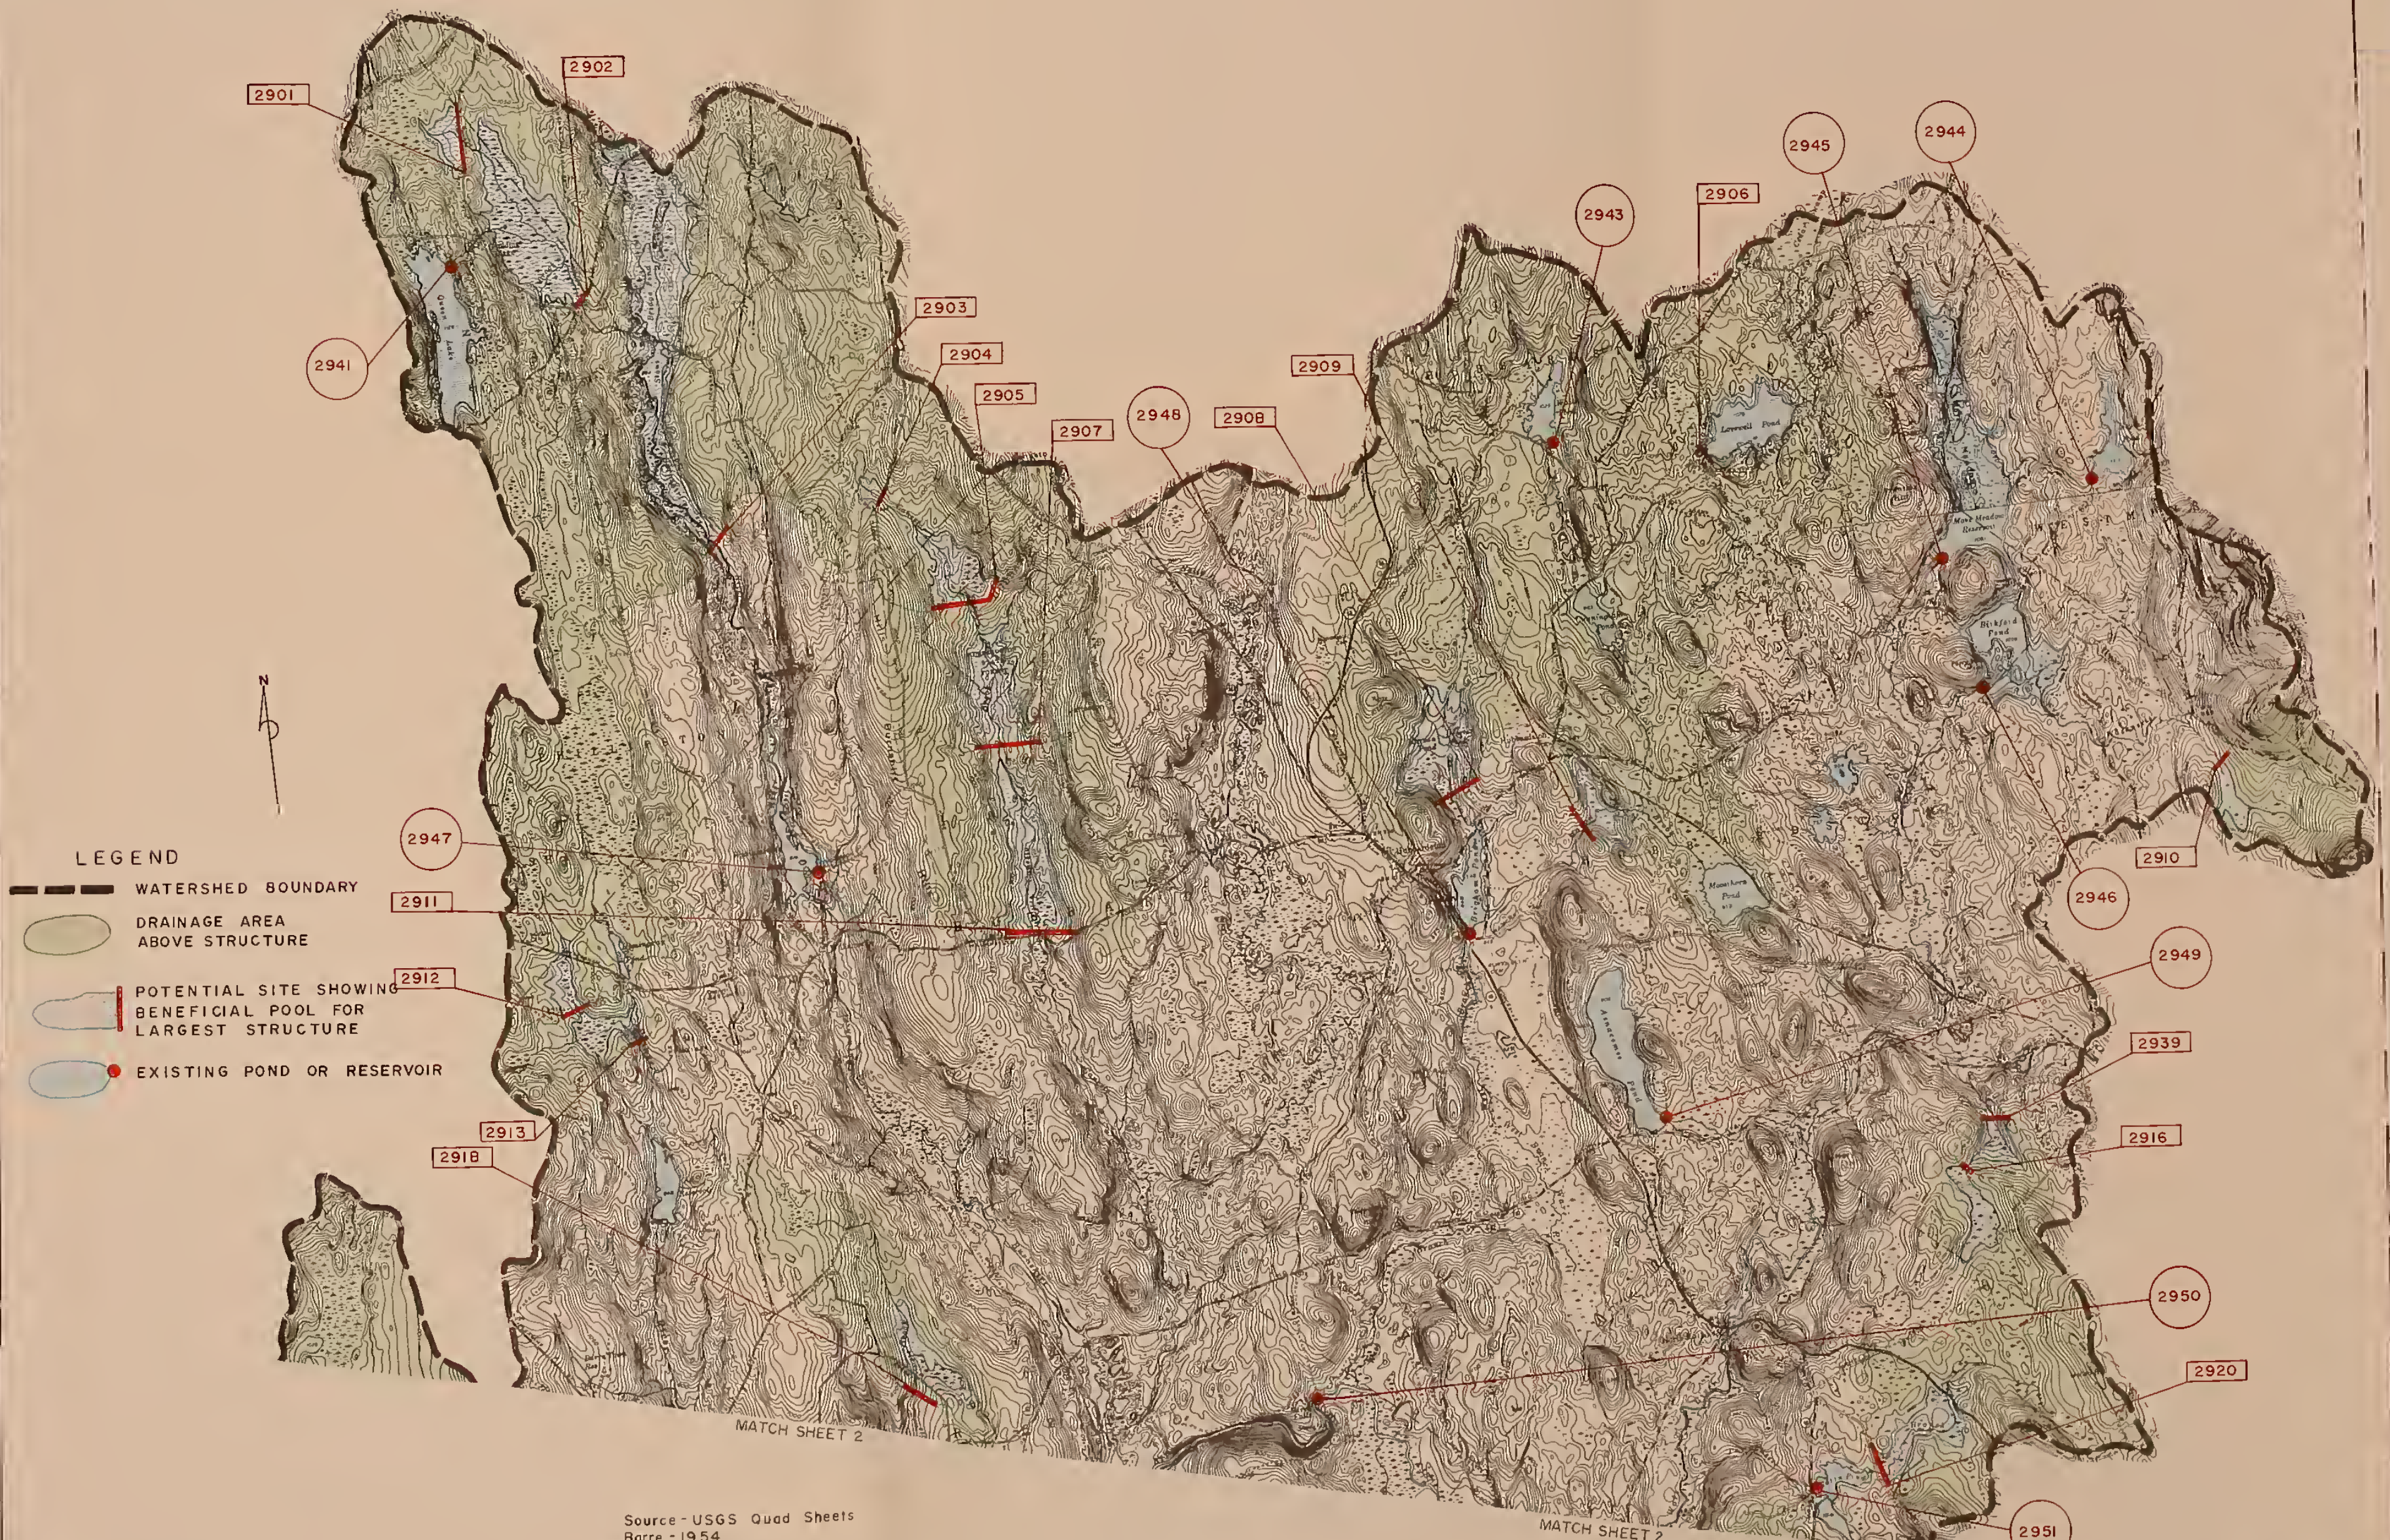
WARE RIVER (CP-29)
CHICOPEE RIVER STUDY AREA
 MASSACHUSETTS
 EXISTING AND POTENTIAL RESERVOIR SITES
 UNITED STATES DEPARTMENT OF AGRICULTURE
 SOIL CONSERVATION SERVICE
 SHEET 1 of 2

Source - USGS Quad Sheets
 Barre - 1954
 Gardner - 1954
 North Brookfield - 1967
 Paxton - 1965
 Petersham - 1954
 Templeton - 1954
 Wachusett Mtn. - 1956
 Ware - 1954

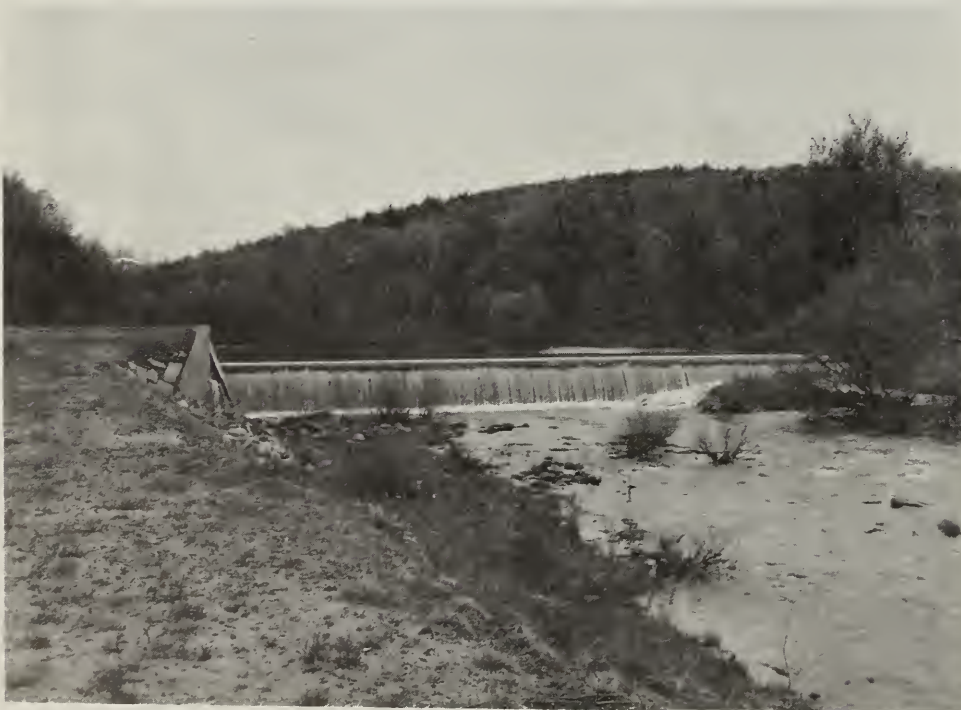
Remarks: The dam is a 125 foot long concrete weir structure. There is a canal sluiceway in the right abutment which diverts water to the Diamond National plant. Masonry on the left sidewall is crumbling.

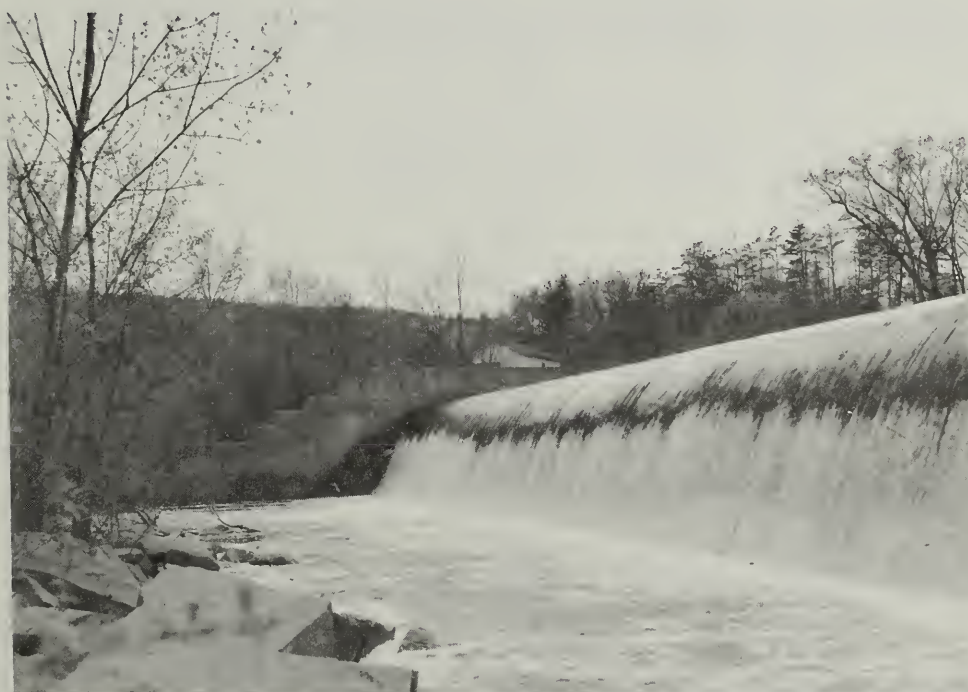
Remarks: The dam is a 125 foot long concrete weir structure. A canal and gatehouse on the right abutment divert water to the Diamond National plant.

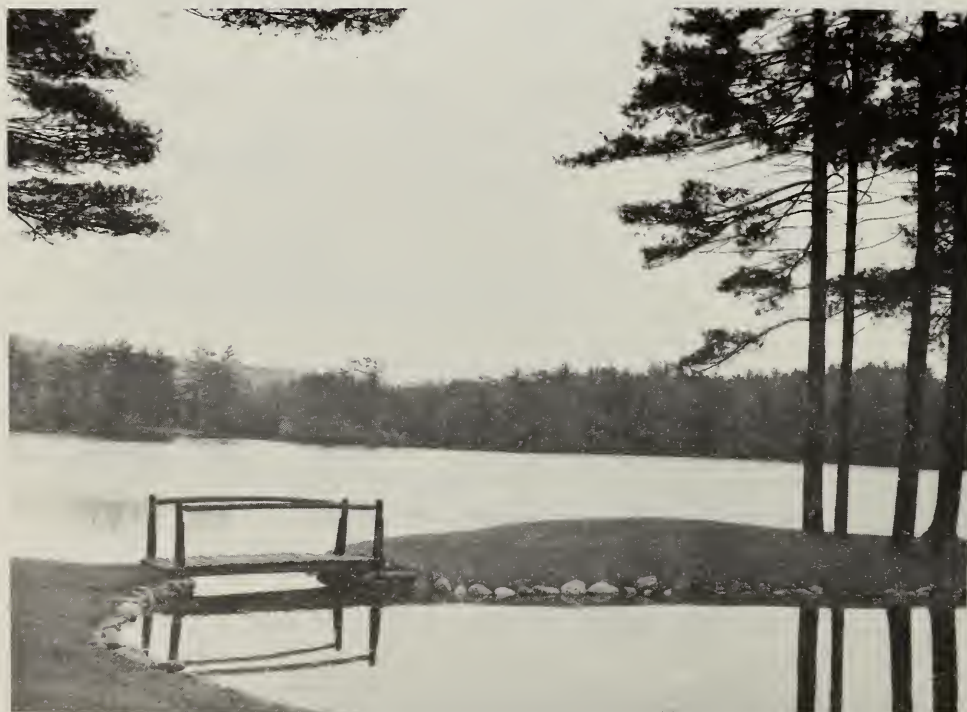
Remarks: The dam is a 120 foot long earth-fill structure with a 10 foot top width. The principal spillway is a concrete weir, 7.5 feet wide and 2.5 feet deep.

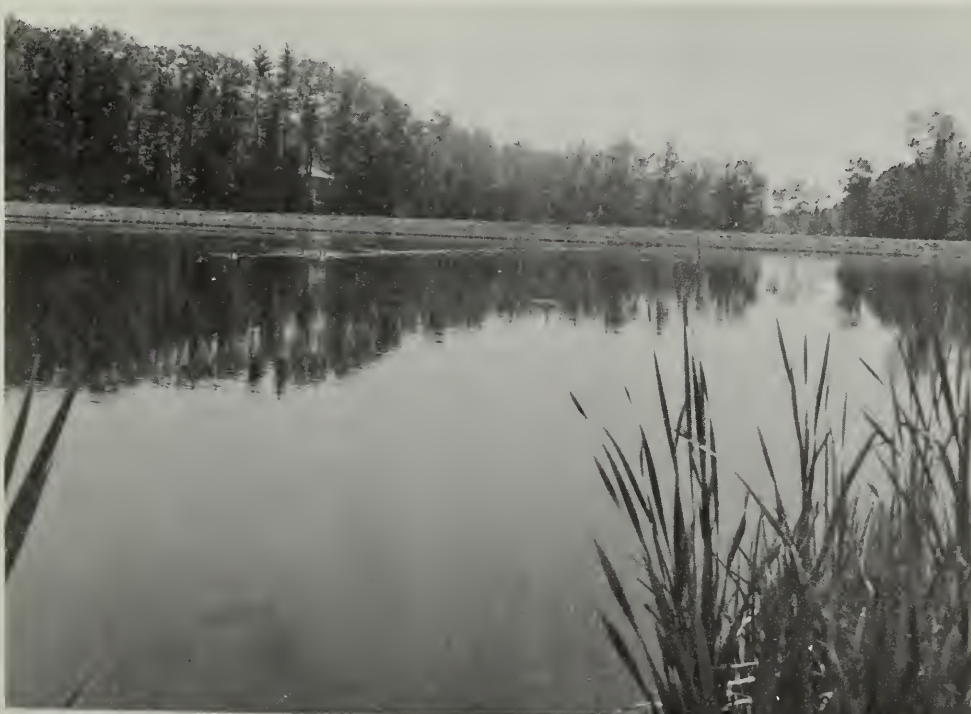
Remarks: The dam is a 400 foot long earth-fill structure. Both abutments are vegetated. The principal spillway is a 72 foot long, 18 inch diameter corrugated metal pipe. The pond drain is a 10 inch pipe.

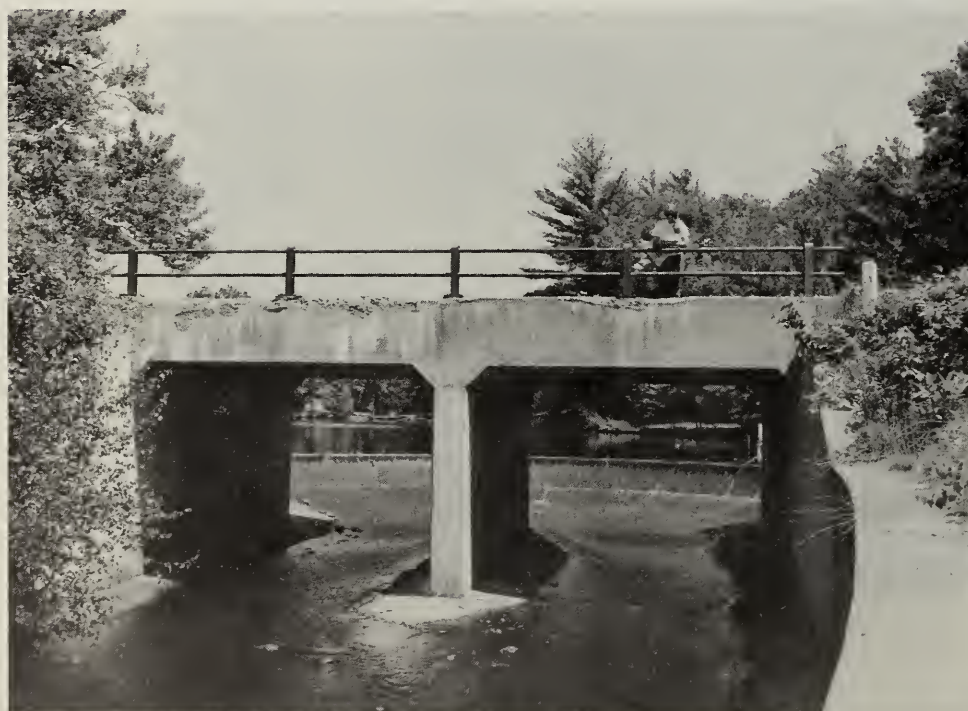
Remarks: The dam is a 250 foot long earth and rock-fill structure with a 30 foot top width. The principal spillway is a 35 foot long crescent-shaped concrete weir.

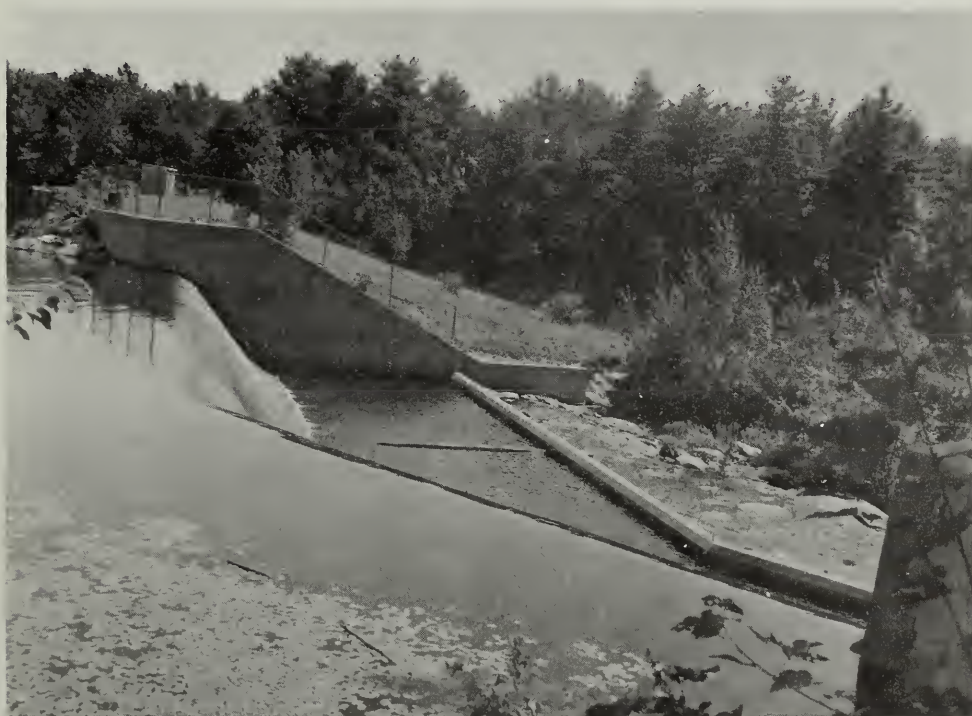
Remarks: The dam is a 325 foot long earth-fill structure with a 10 foot top width. The downstream slope is grassed; the upstream slope has rock riprap. The principal spillway is composed of two straight sections of ogee weir. A concrete lip at the end of the outlet channel acts as a stilling basin.

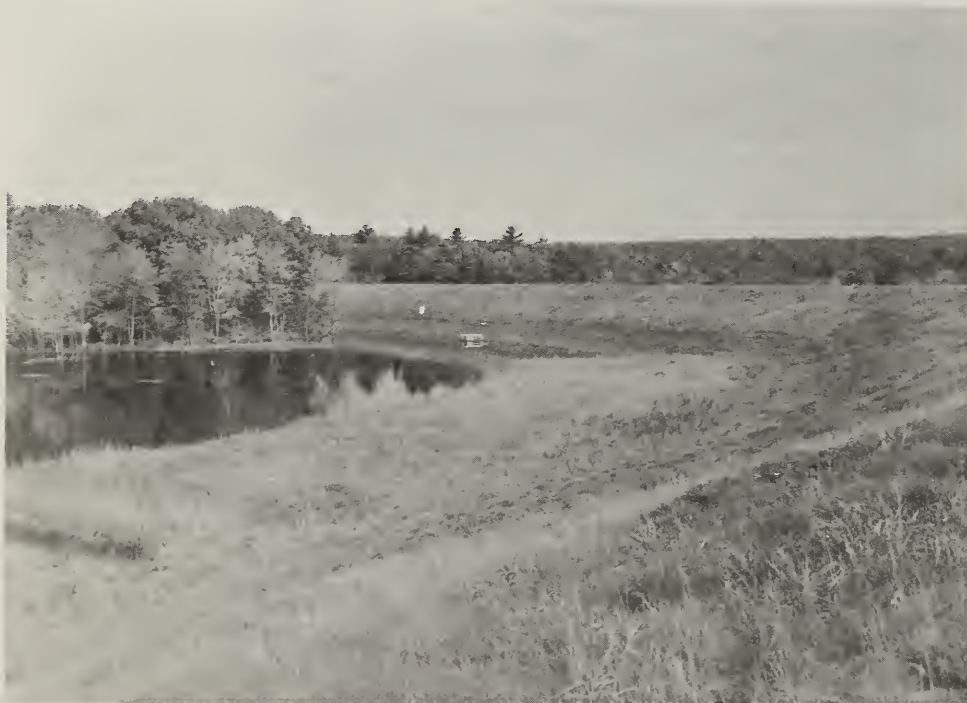
Remarks: The dam is a 1000 foot long earth-fill structure with a 12 foot top width. The principal spillway is a 30 inch diameter concrete conduit with a riser inlet structure. The riser is equipped with stop logs to control the water level. The vegetated emergency spillway is 300 feet wide. The site has capacity for 13 acre-feet of sediment storage, 26 acre-feet for fish and wildlife improvement and 1370 acre-feet for flood-water.

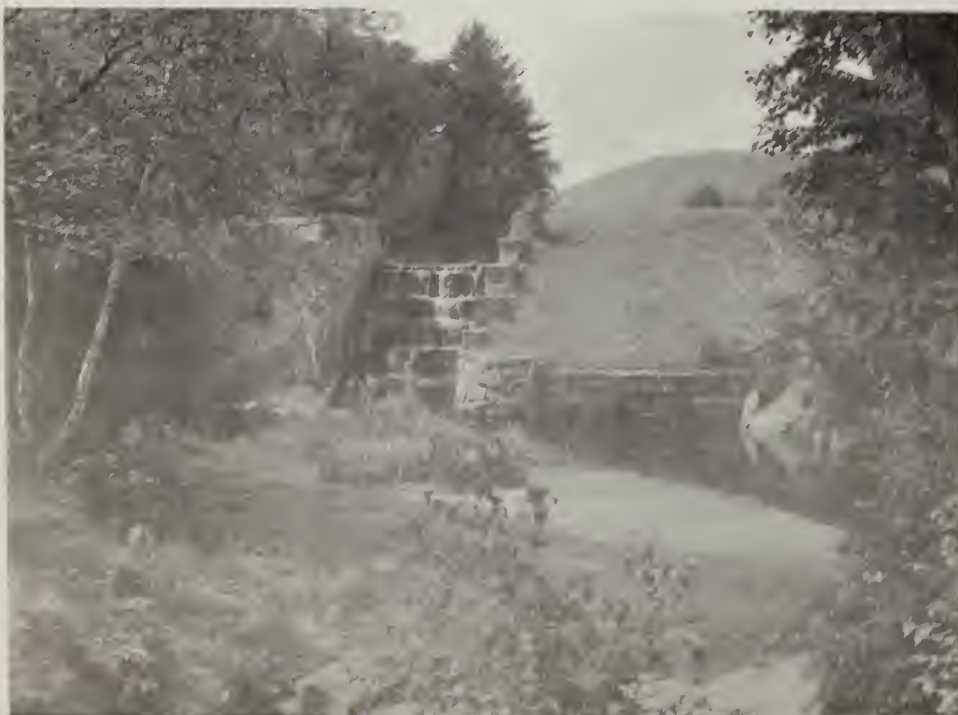
Remarks: The dam is a 50 foot long earth-fill structure with an 8 foot top width. The spillway is a 15 foot wide stone masonry structure. The outlet channel is a series of 5 masonry steps.

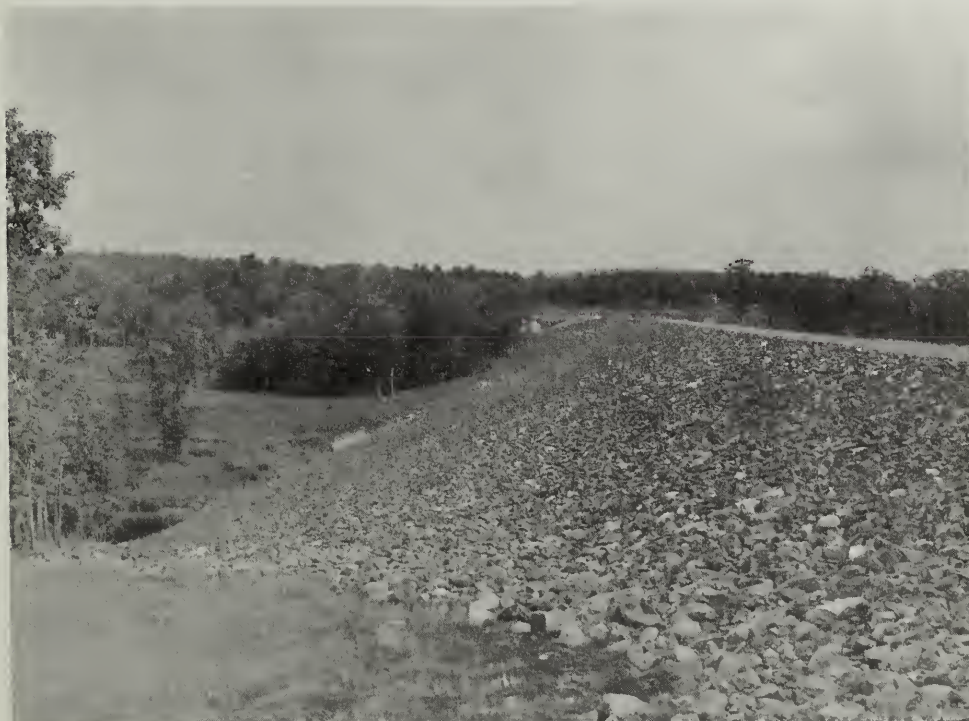
Remarks: The dam is a 1000 foot long earth-fill structure with a 16 foot top width. Both slopes are riprapped. The principal spillway is a gate control structure. The emergency spillway is a concrete ogee weir located on the left abutment. The flood pool has a capacity of 3740 acre-feet.

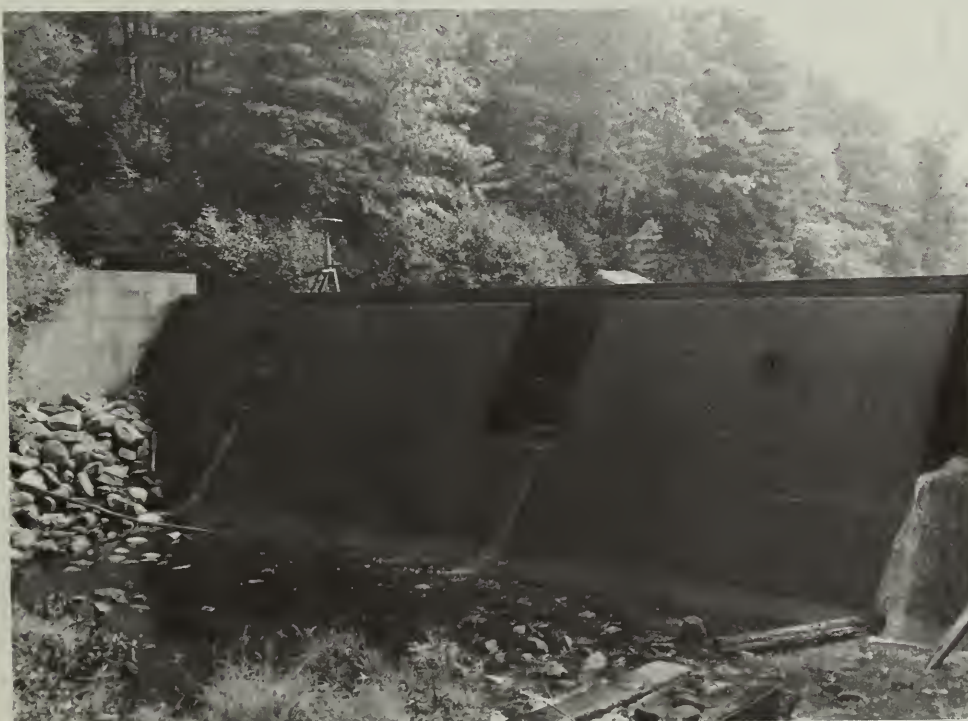
Remarks: The dam is a 75 foot long concrete weir structure with two stages. The low stage is a 4 foot wide by 8 foot high opening fitted with stop logs. The high stage is the top of the dam fitted with flashboards. There is a 3 foot diameter gated outlet at about the same elevation as the low stage weir.

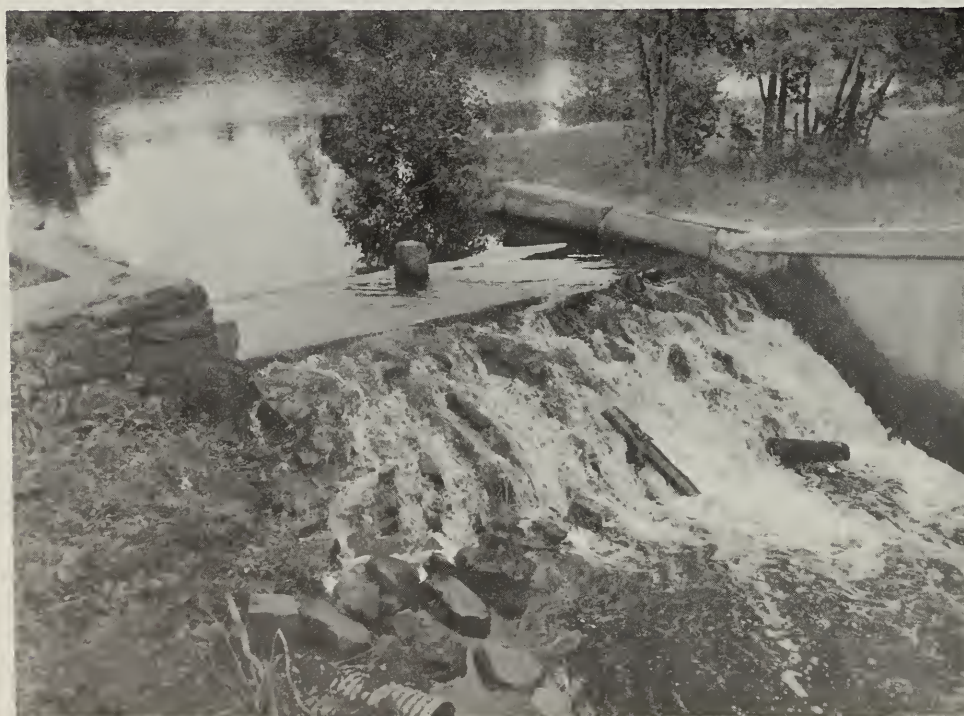
Remarks: The dam is a 12 foot long stone masonry structure.
Concrete in the sidewalls and outlet channel is
deteriorated.

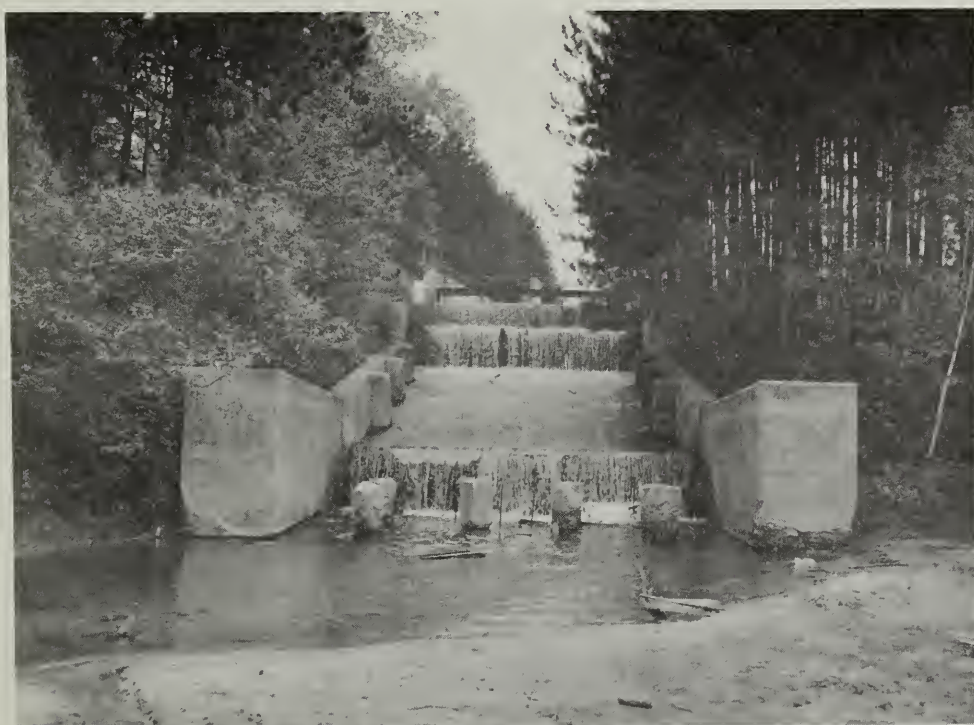
Remarks: The dam is a 550 foot long earth-fill structure with a 20 foot top width. The upstream side is faced with concrete. The spillway is a four-step concrete chute structure, about 60 feet wide. Concrete in the side-walls and chute blocks is badly deteriorated.

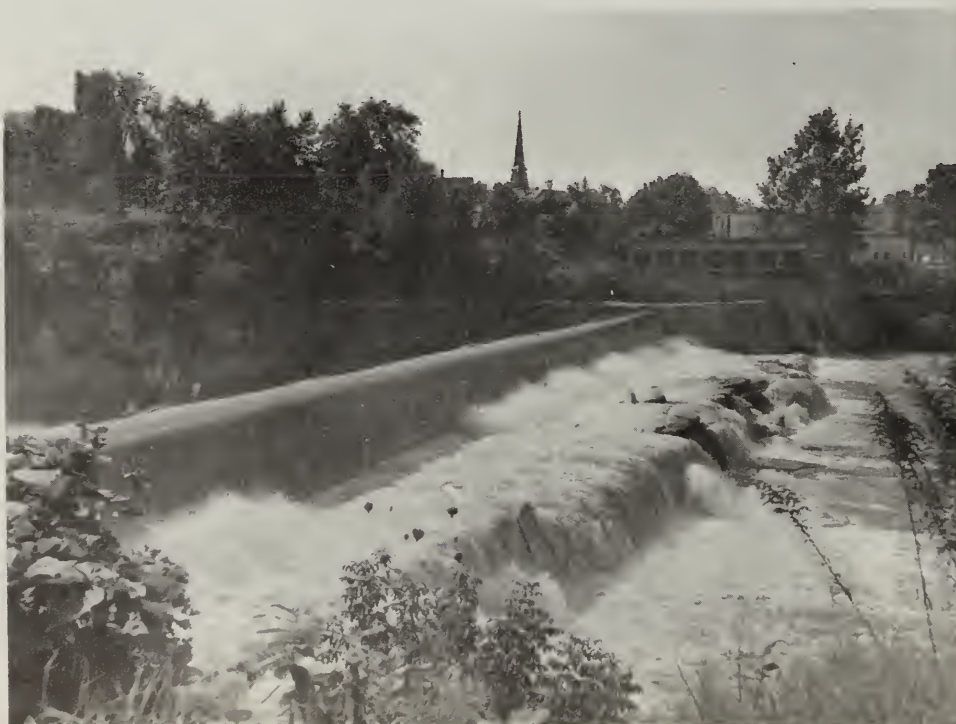
Remarks: The dam is a 300 foot long concrete weir structure constructed on a rock terrace 5 feet above the river-bed. The concrete weir structure is about 5 feet high. The left end of the dam contains a gate house with two 4 foot by 6 foot concrete monolithic outlets.

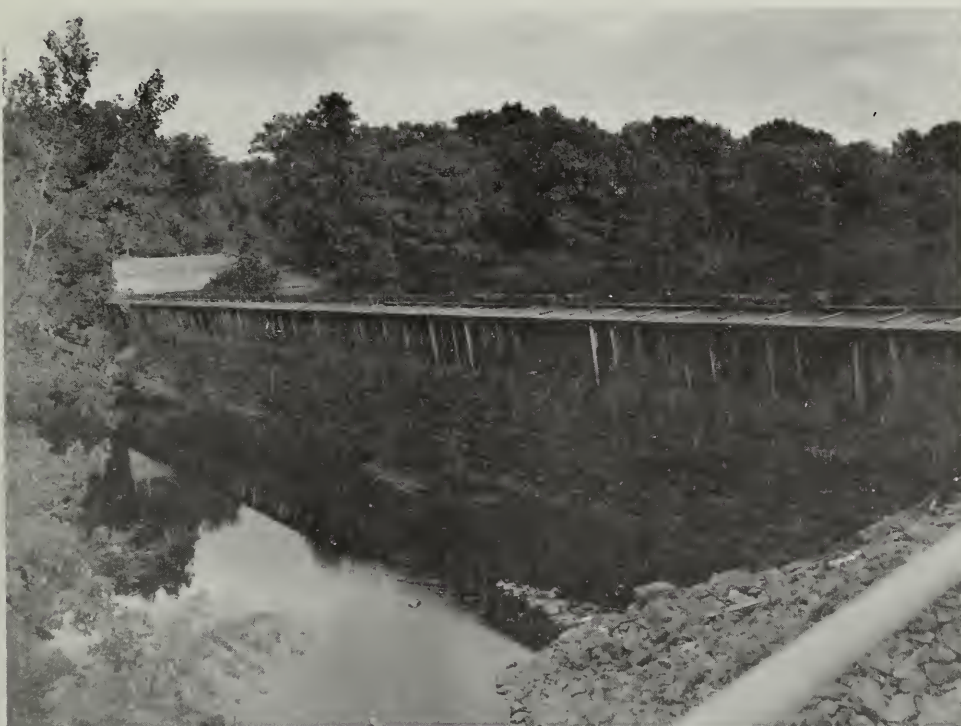
Remarks: The dam is a 600 foot long stone masonry structure with flashboards. A gatehouse controls flow to a canal located on the left abutment. Brush is growing on the downstream side of the dam.

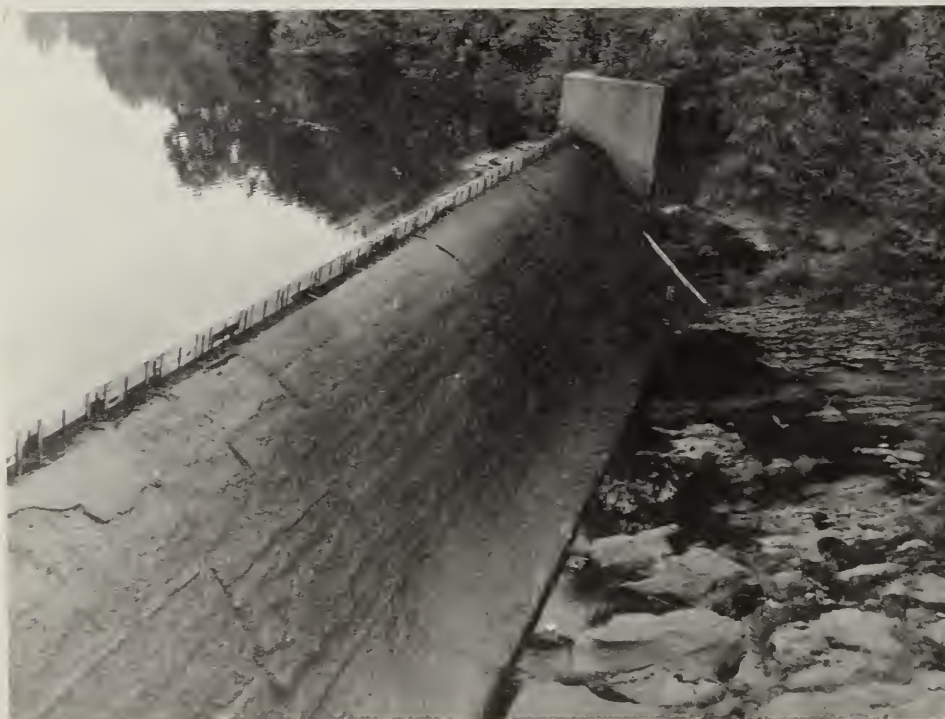
Remarks: The dam is a 125 foot long concrete dam with an ogee
weir section equipped with flashboards.
